New Water Plant Equals Improved Water Quality in Easton, Kansas

Easton's new iron and manganese removal plant and new well and distribution system improvements cost \$2,056,000.

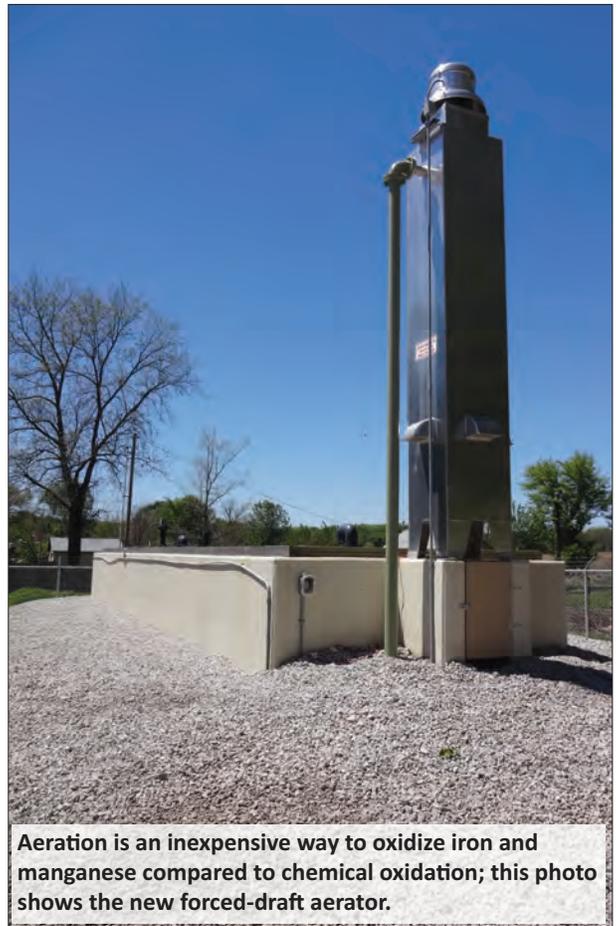
Aeration is an inexpensive way to oxidize iron and manganese compared to chemical oxidation; this photo shows the new forced-draft aerator.

then routed to a forced-draft aerator for further oxidation of iron and manganese. Potassium permanganate is then added after the aerator and before the rectangular sedimentation basin. This basin has two compartments with the first one having a hopped bottom to allow for removing settled iron and manganese. Sediment on the bottom of this basin is periodically pumped to the city's sanitary sewer. The basin is also covered to keep out debris and minimize chlorine loss. Water is then pumped to the three pressure filters which operate in parallel. The flow rate through each filter

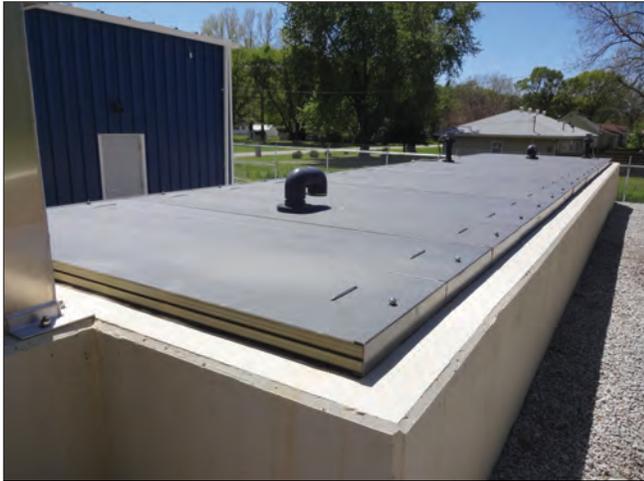
This photo shows the new covered sedimentation basin with hopper-bottom. Water is then pumped from the far end of this basin to the pressure filters.

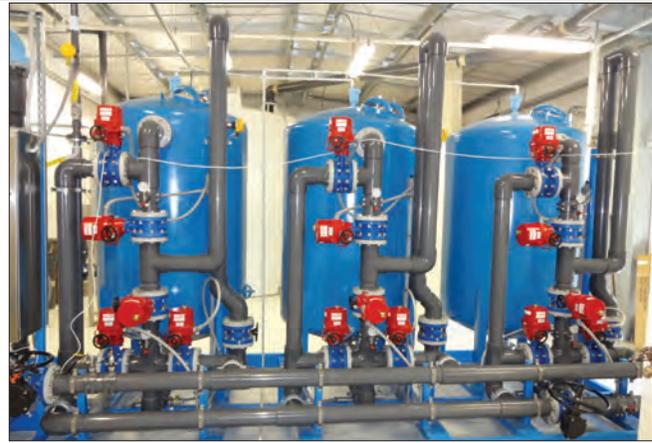
This photo shows the three Wigen pressure filters. This is the final treatment stage for removing any remaining iron and manganese from the water.

The centerpiece of the new treatment plant is three vertical pressure filters manufactured by Wigen Water Technologies, Chaska, Minn. Raw well water is pumped from Wells 2 and 3 to the plant where chlorine (pre-chlorination) is added. Chlorine solution is added to both disinfect and oxidize the iron and manganese. Liquid sodium hypochlorite (12.5 percent) solution is added using a ProSeries-M peristaltic pump. Water is

is 20 to 22 gpm. The filter media is specific for removing iron and manganese. Some arsenic is also removed. Filtered water then flows into a new 36,000-gallon clearwell. This line from the filter to the clearwell has a tap for adding chlorine (post-chlorination) in order to maintain adequate residuals in the system. Two 77-gpm high service pumps pump treated water into the distribution system. In addition to the clearwell, the city has a 60,000 ground level, concrete storage tank on a hill southwest of town.

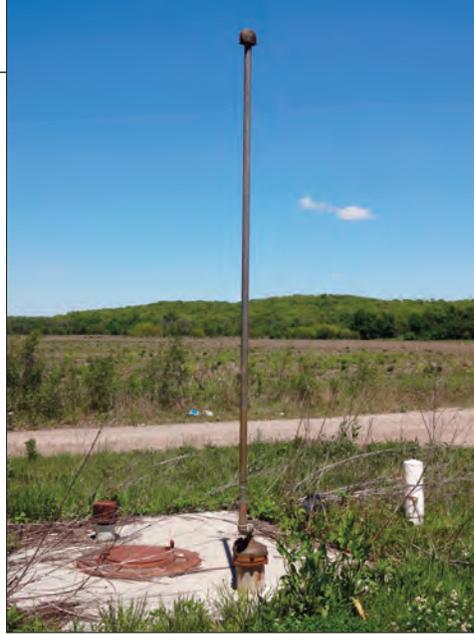
This photo shows Well No. 3 with extended well vent. KDHE requires the elevation of the well vent be not less than two feet above the 100-year flood level.
